# Landowner Beaver Management Experience

Case Study: Saddle and Sirloin

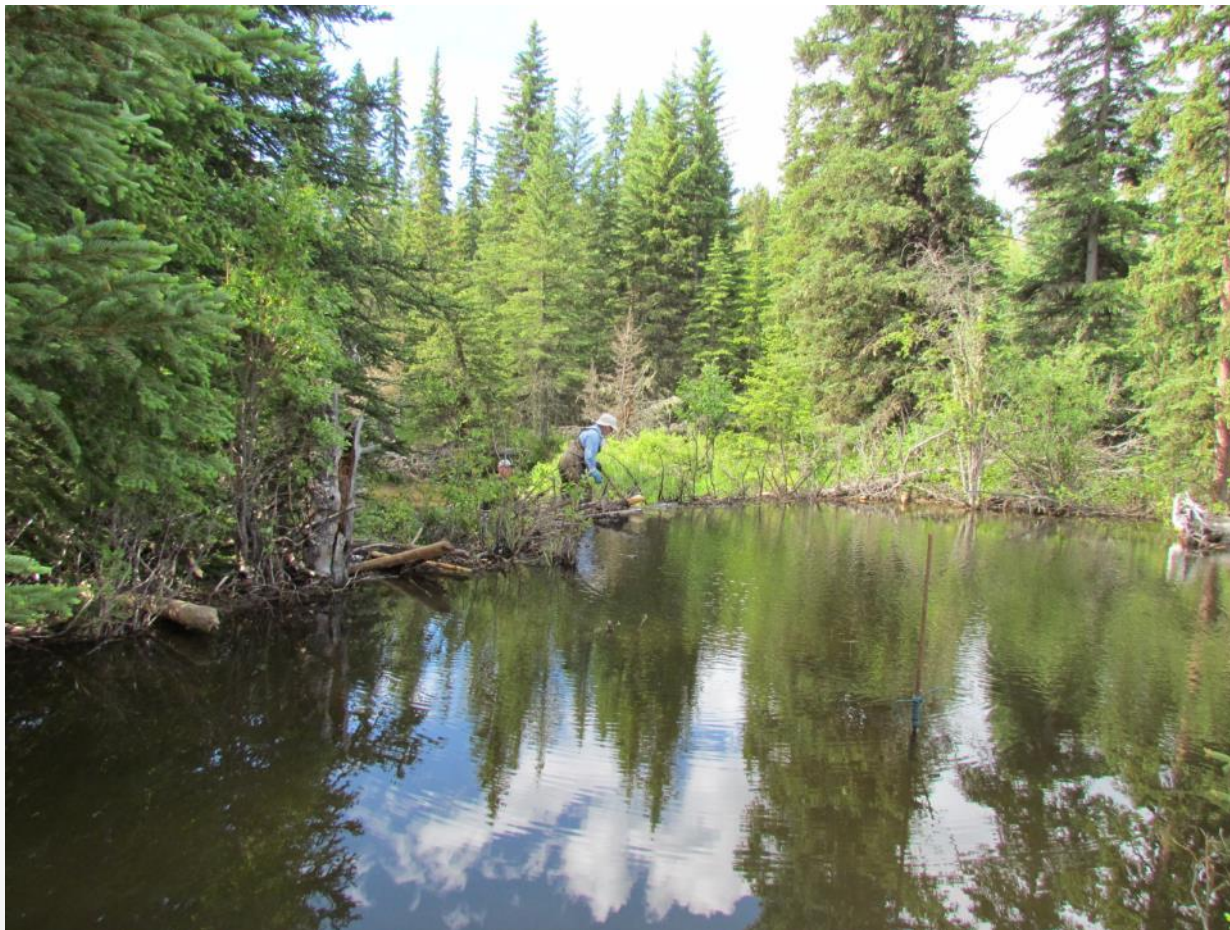
- Beavers flooding common grazing lands in the Saddle and Sirloin community

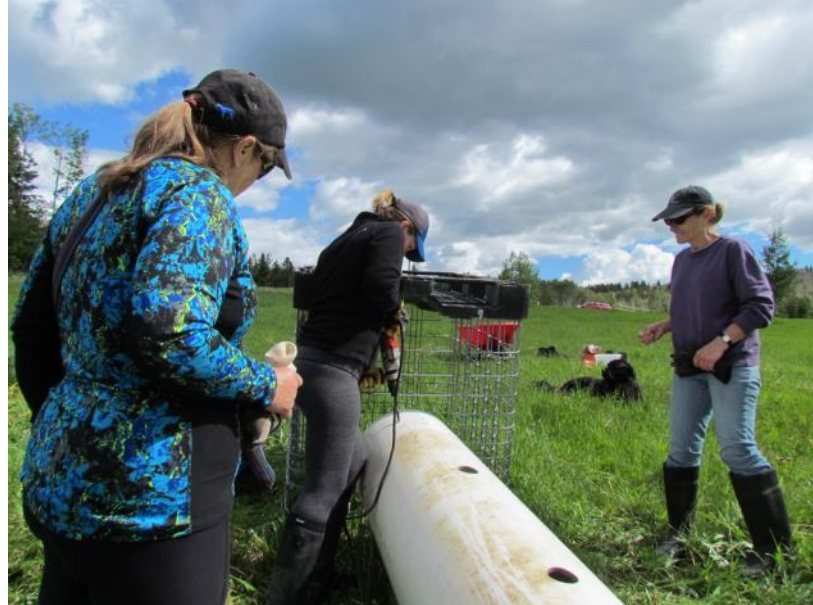
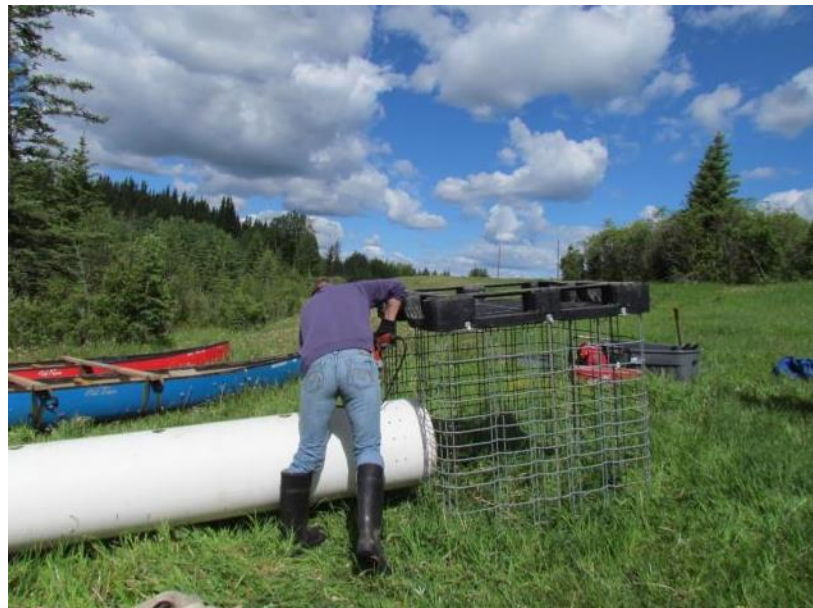
- Materials
  - Pipe (waste material from construction company)
  - Cage around inflow side of pipe (from empty water container, waste)
  - Tools (borrowed)
  - Elbow grease
    - 6-8 volunteers efficiently completed the installation in one afternoon

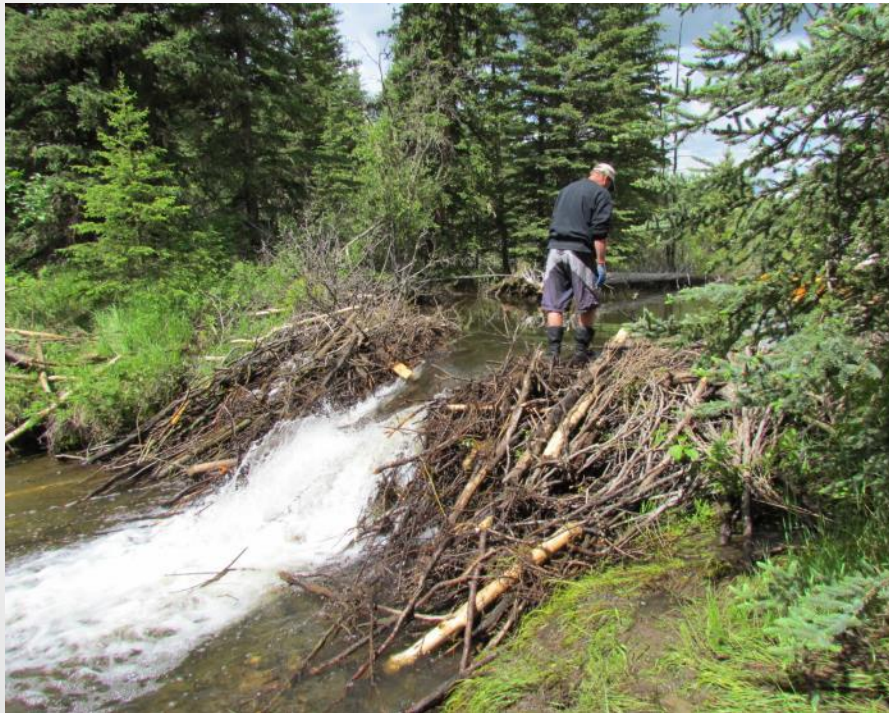
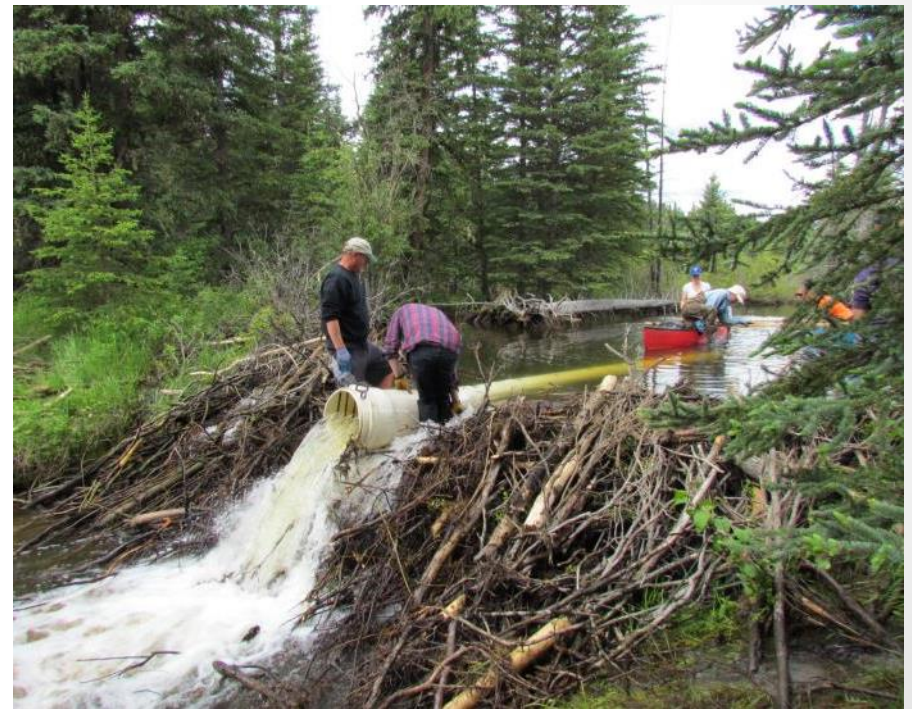
- Dam was partially excavated to allow for pipe outflow installation

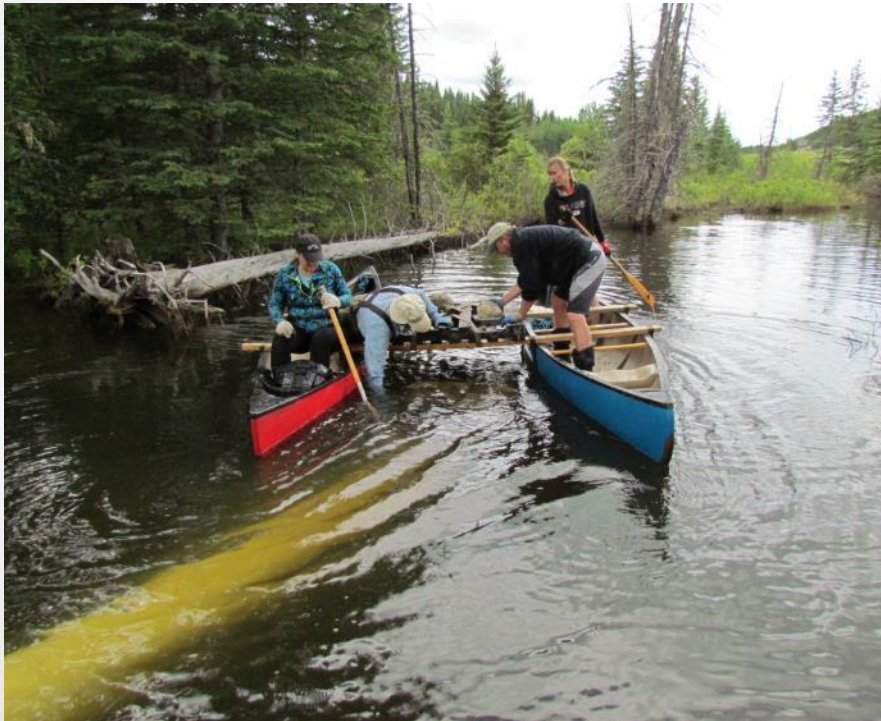
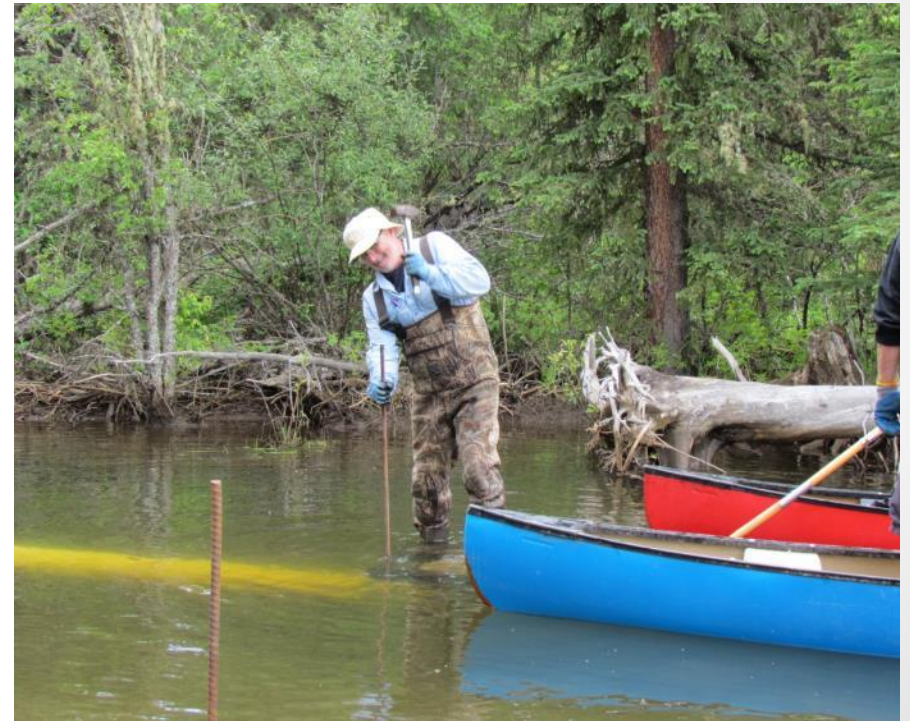
- Inflow pipe end was sunk with rocks and staked into place

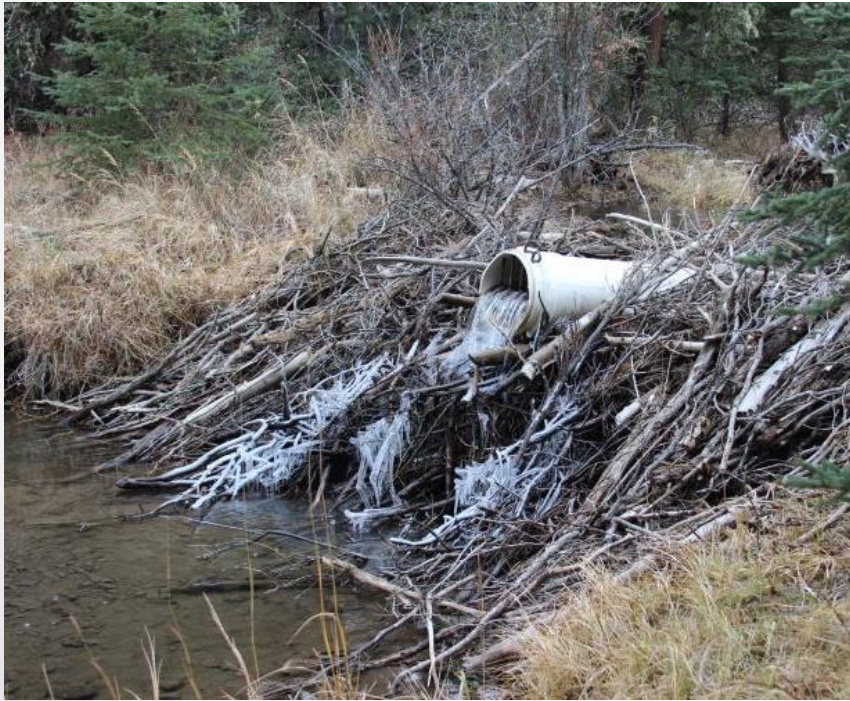
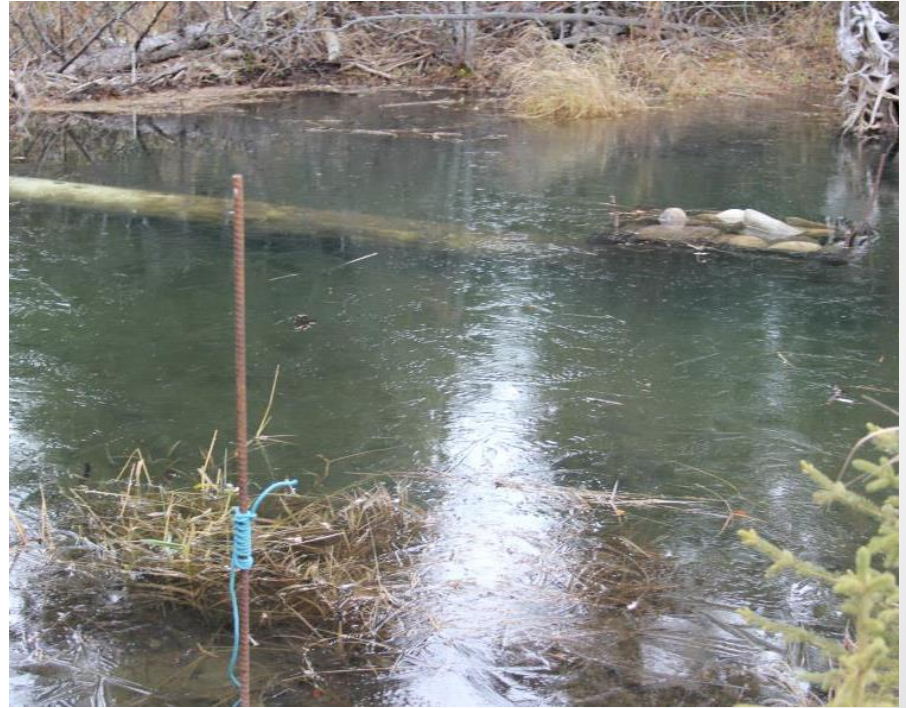
- The water level dropped 10 inches and the beavers were able to stay in place, providing benefits to the community while no longer being a 'pest'
